# Service Experience of MAN B&W Two-stroke Diesel Engines

Stig B. Jakobsen  
Senior Manager  
Low Speed – Operation

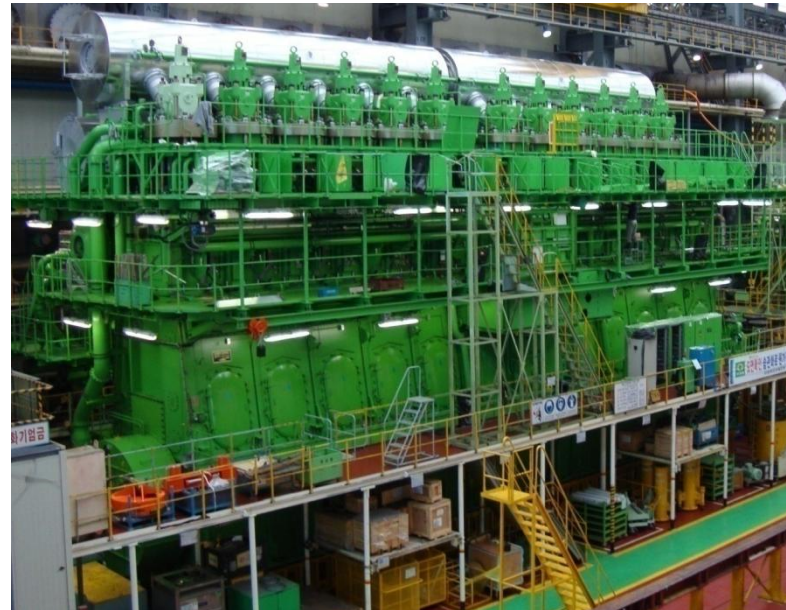
## Constant Focus on First-Cost Cost-Down Example: Low Force Exhaust Valve

Potential First Cost Saving: 200,000 USD for a 12K98ME/ME-C Engine

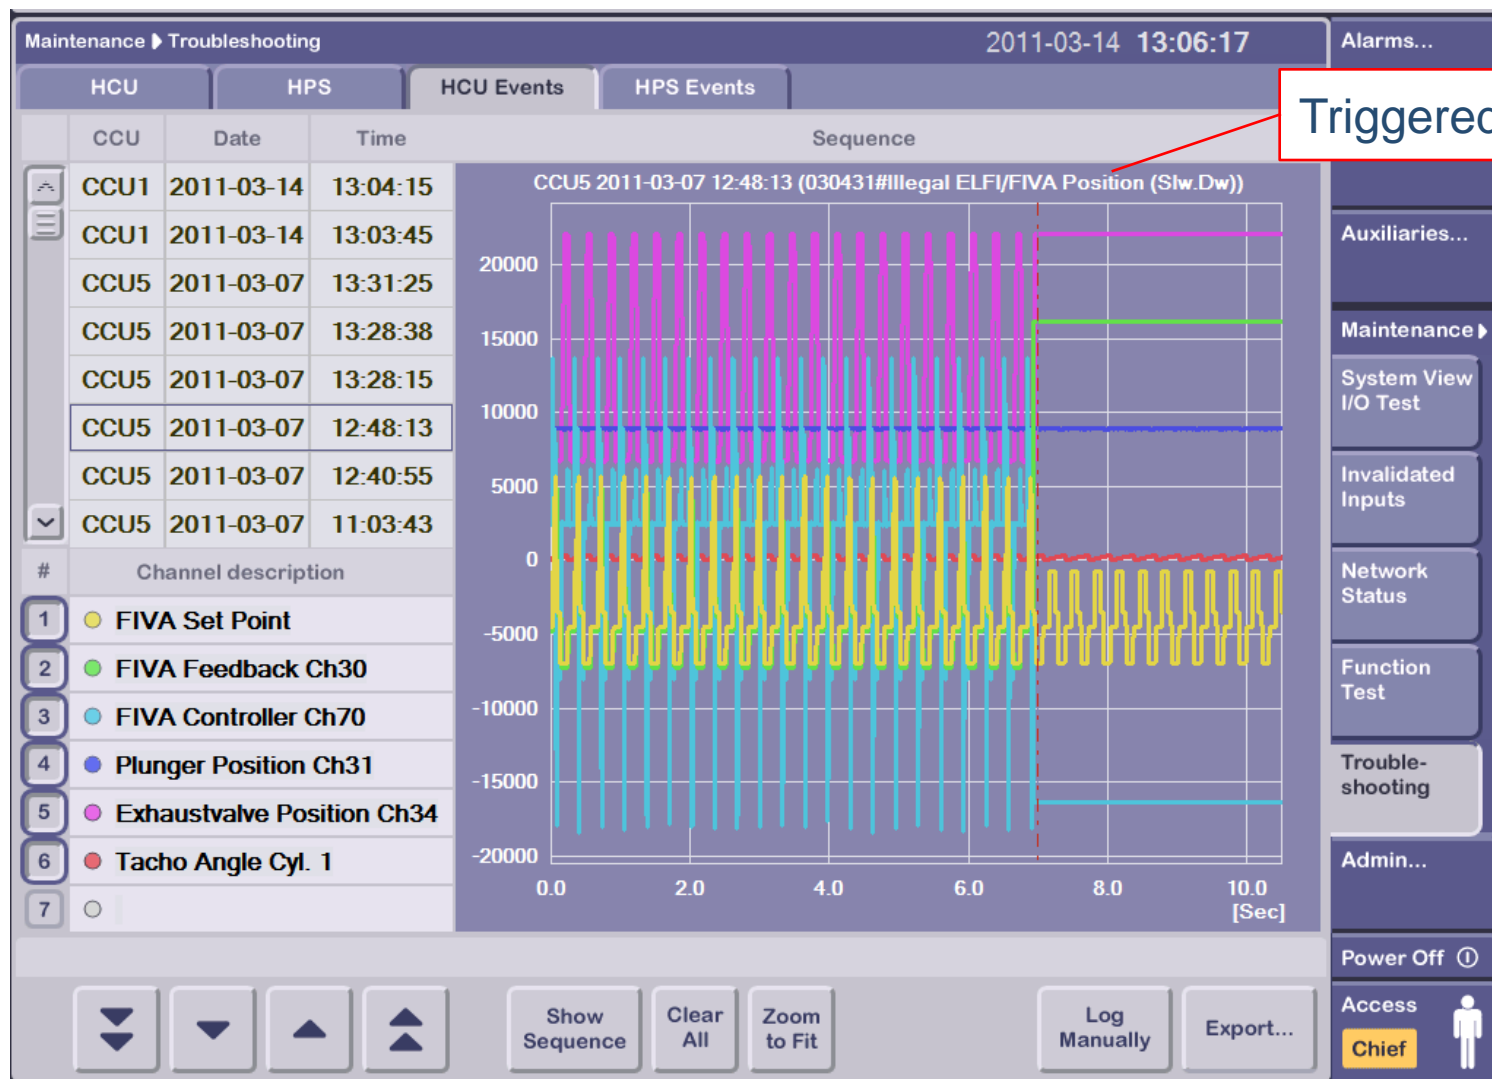
# Data Logger for HCU

Triggered by event

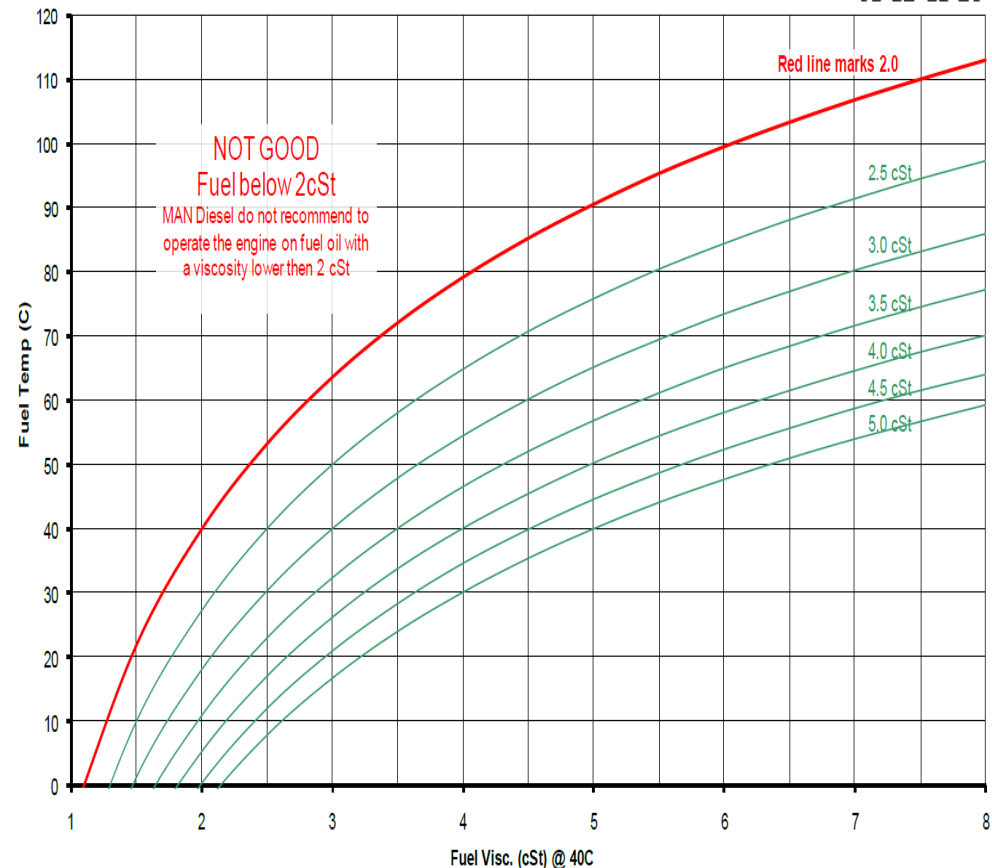
Temperature of MGO to ensure viscosity below recommended 2 cSt

Fuel temp vs Viscosity

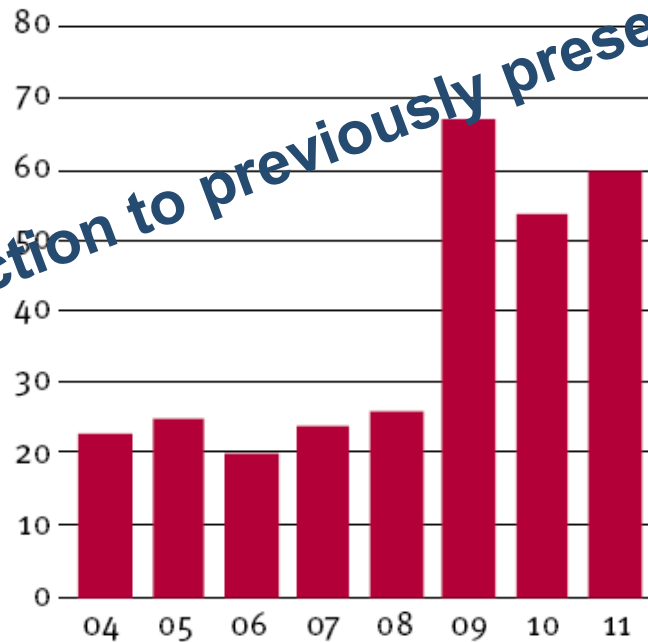
## LOSS OF PROPULSION INCIDENTS

January 2004 to August 2011

Number of incidents

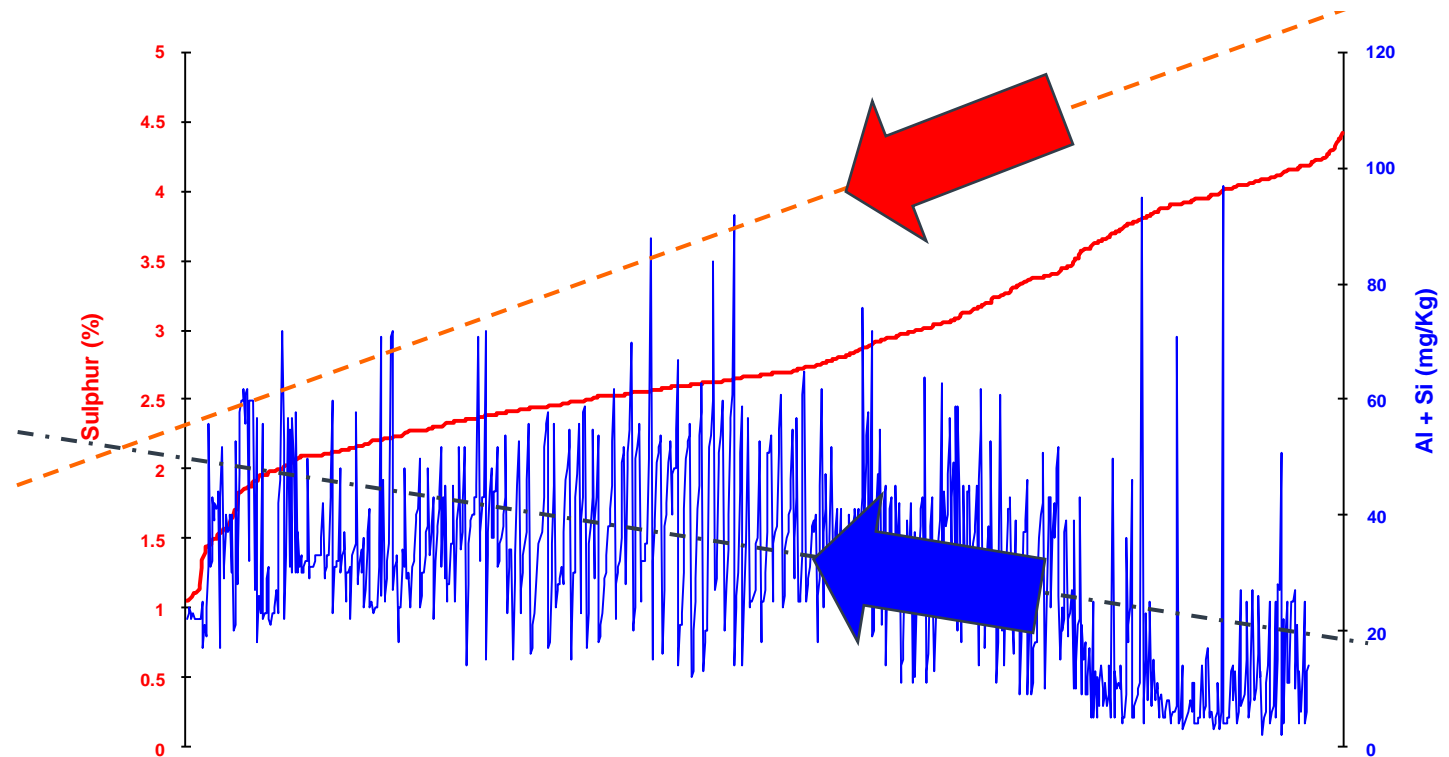
Challenge of Low sulphur HFO; the lower sulphur the more cat-fines

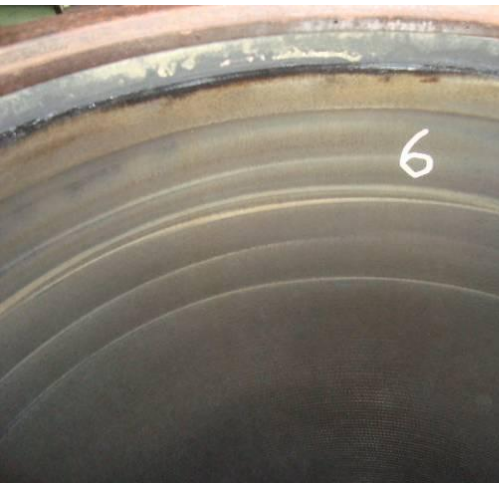
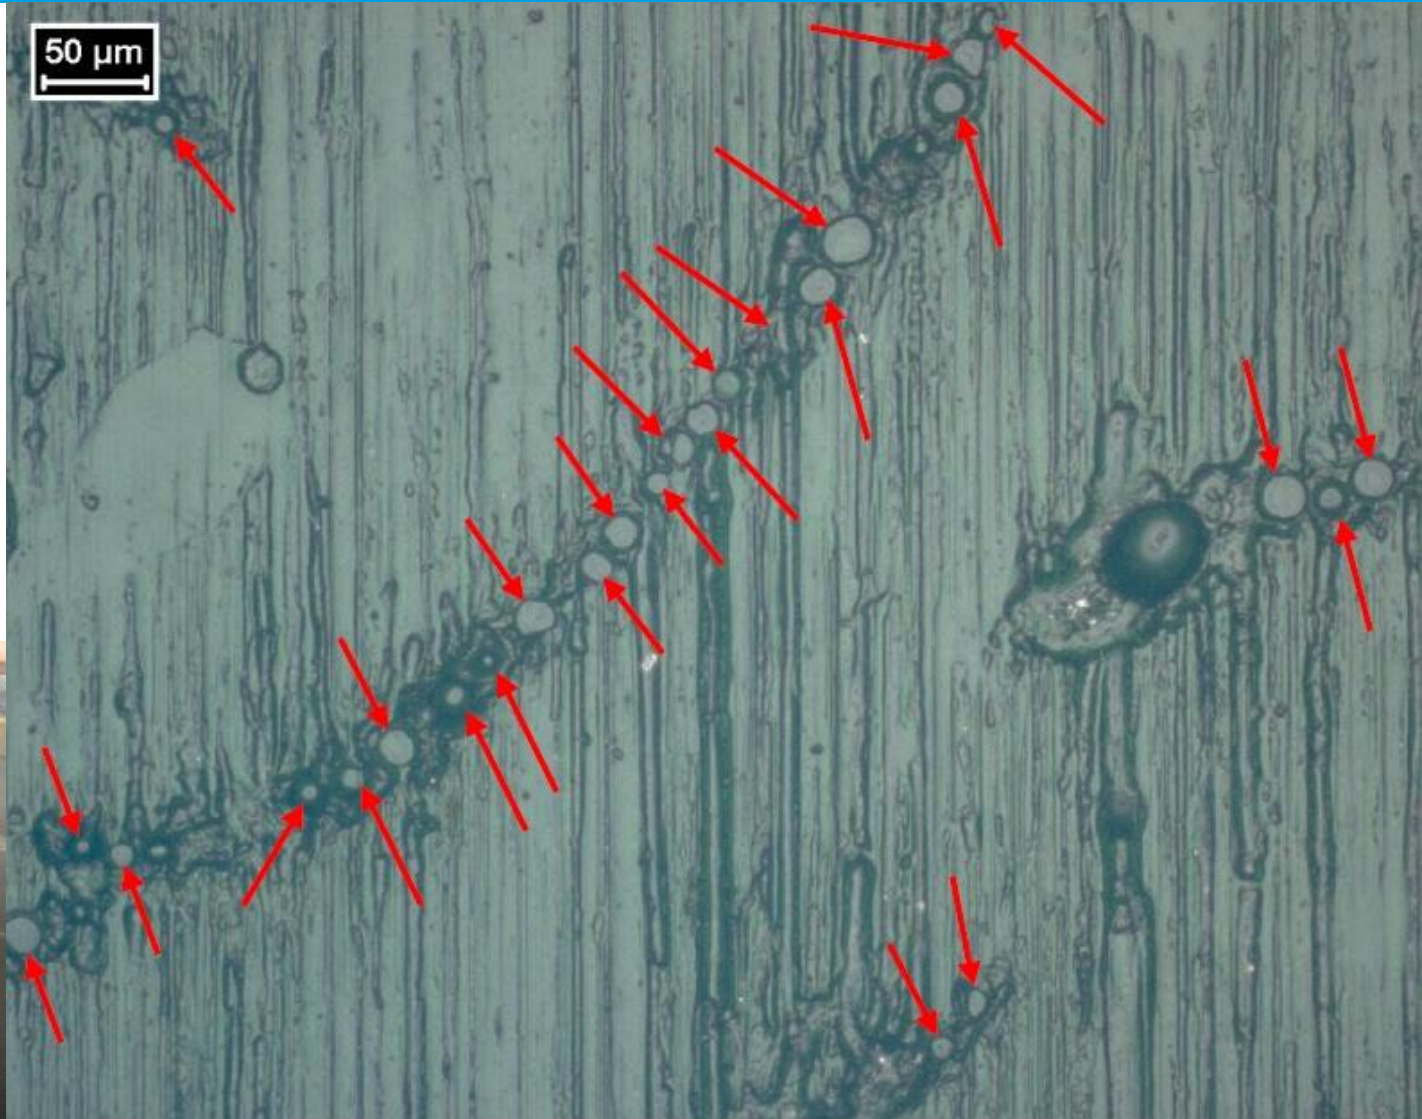
## Replica technique:

- The density of cat-fines was found extremely high, with up to 3,000 / cm<sup>2</sup>. Acceptable level is below 200 / cm<sup>2</sup> !
- The sizes vary from 5µm to 15 µm with a smaller number of "big" cat-fines in a range of 20 – 25 µm.
- This is a result of inefficiently working centrifuges.

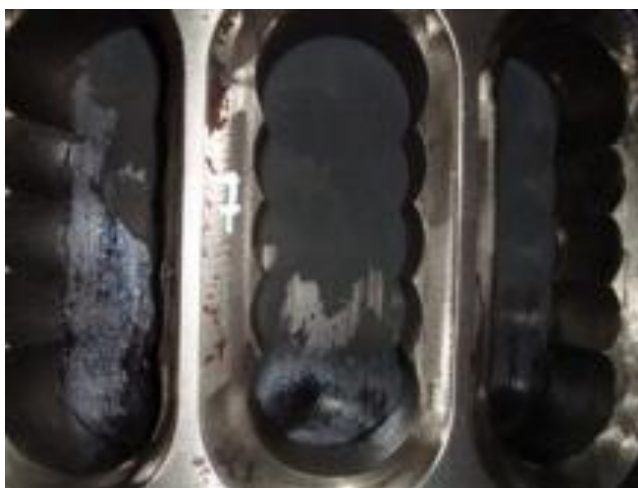
Inspection before test

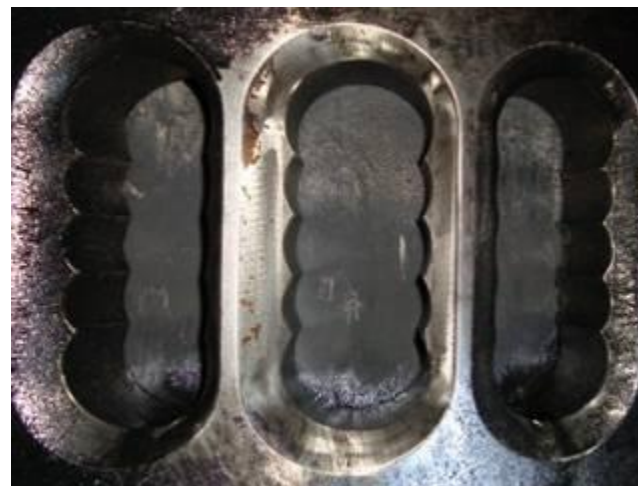
Inspection after 3-day test

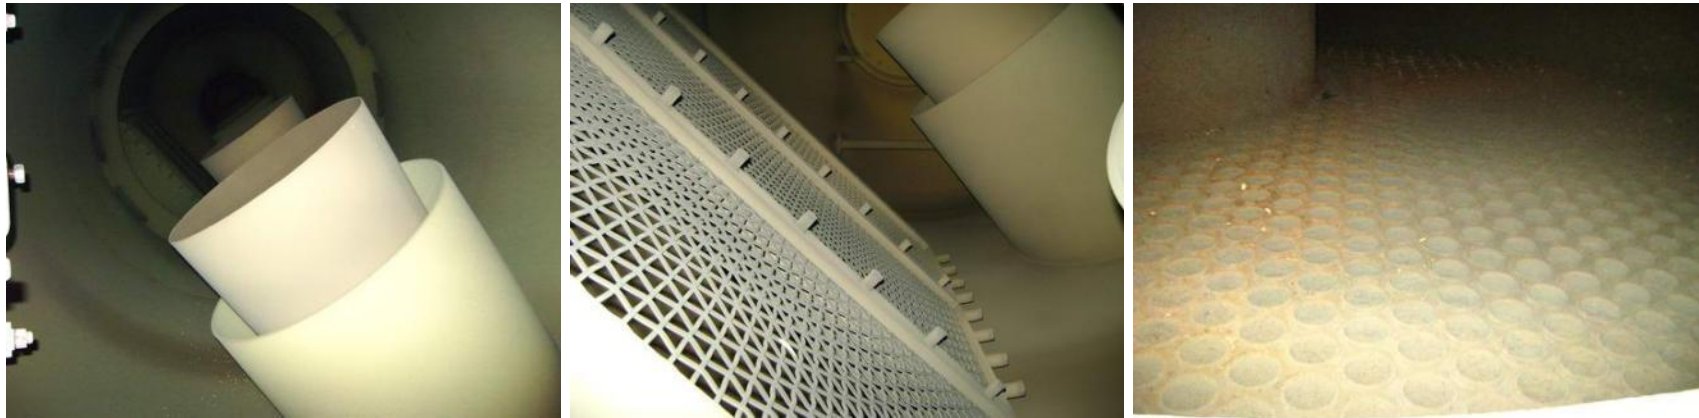
## Exhaust receiver / boiler top

*After 509 hrs of slow steaming we do not see the dire necessity of cleaning it. Did not find any abnormalities or signs of over-lubrication. Sludge amount in the corners and on the walls was normal.*

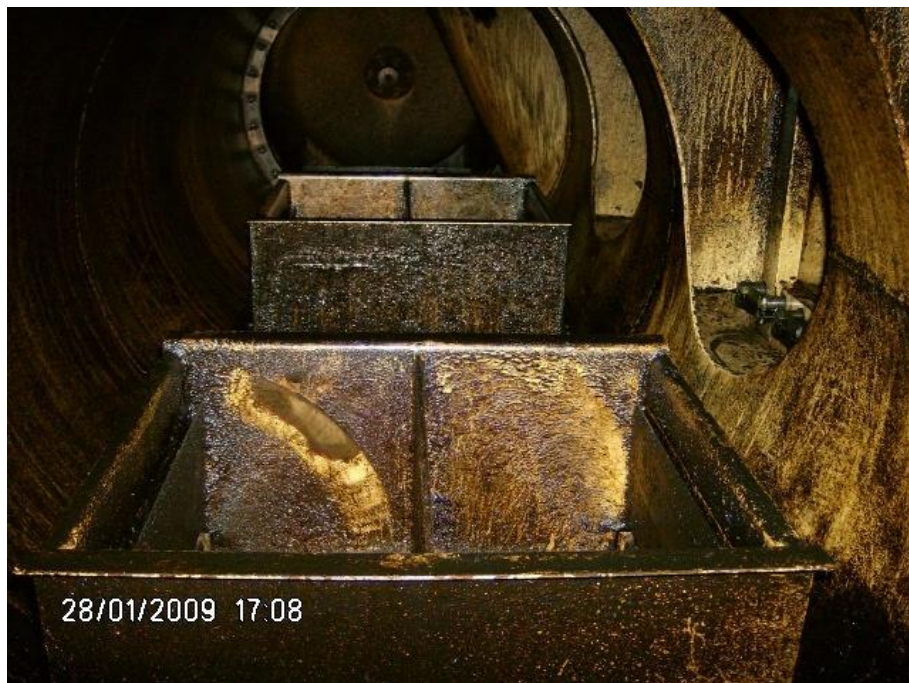
### Scavenge air receiver

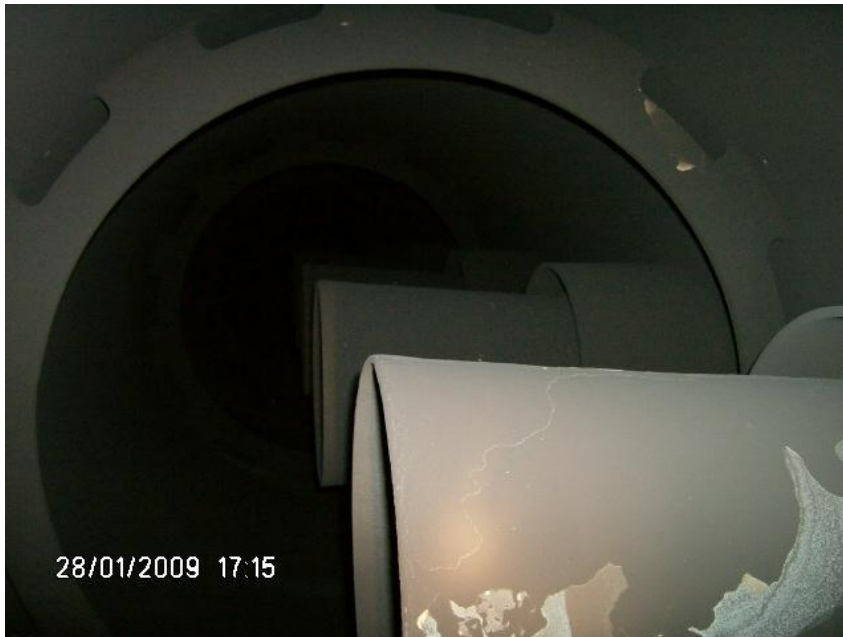
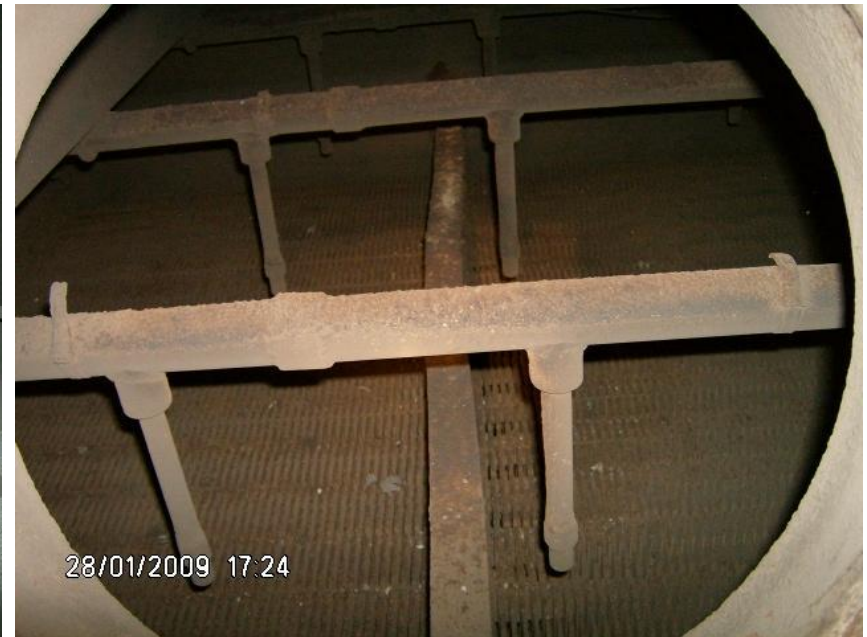
## Exhaust receiver / boiler top

- Did you experience any problems related to the slow steaming operation?  
*Answer: NO*

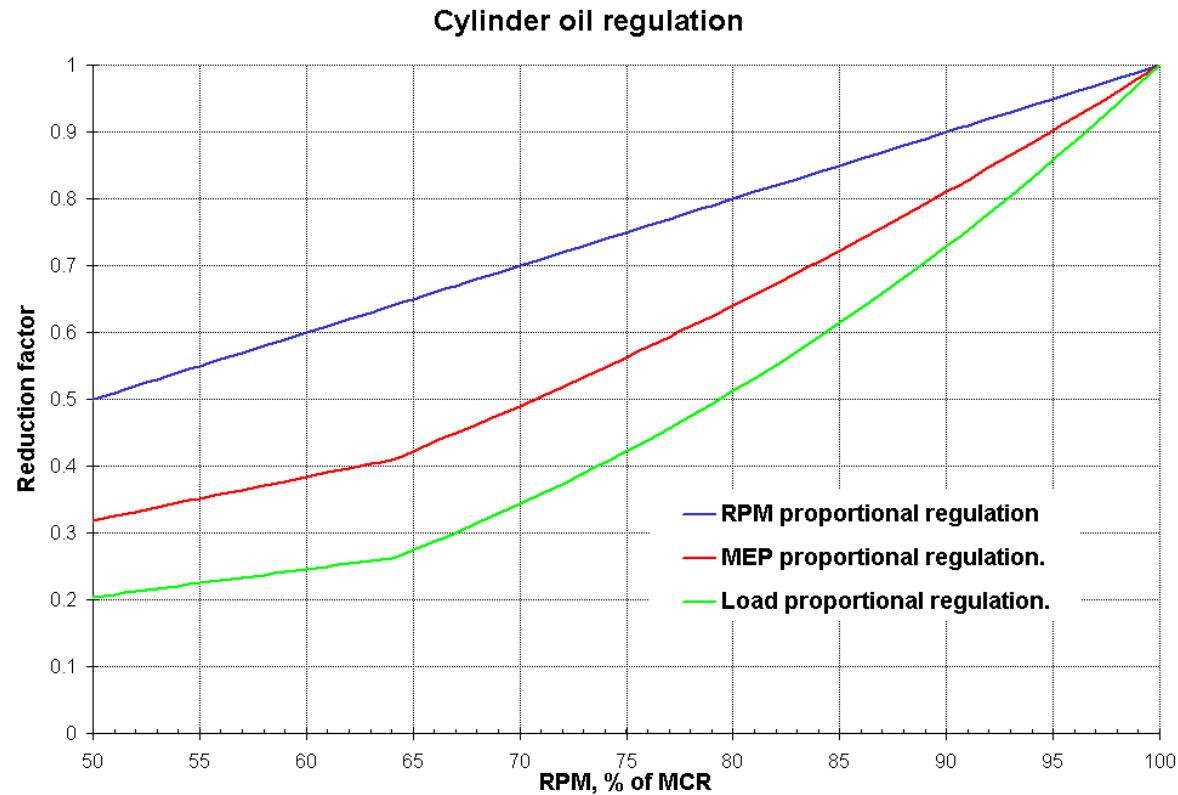
For engines with Alpha lubricators (lubrication as a function of engine load), significant savings can be made on cylinder lube oil consumption

80% RPM of MCR results in a reduction of 50%

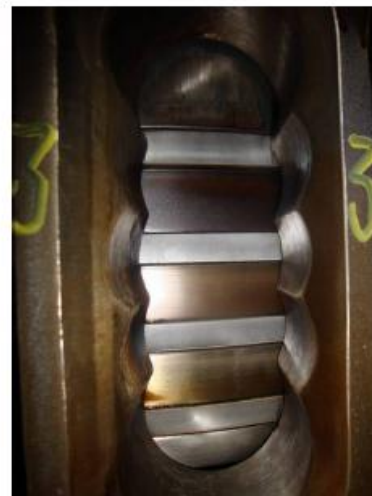
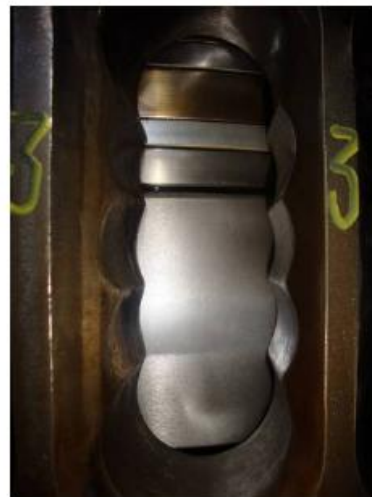
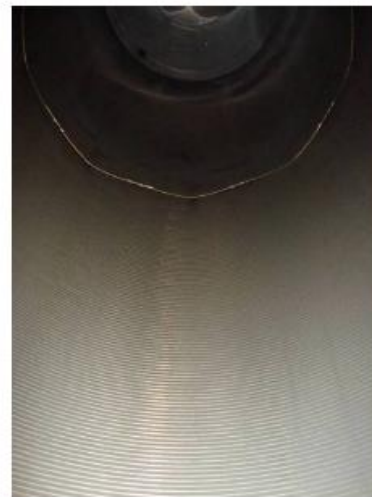
Condition of piston and rings:

Good condition with no signs of abnormal wear.

Liner: Excellent condition. WC still visible.

Flat rate test at 0.55g/kWh.

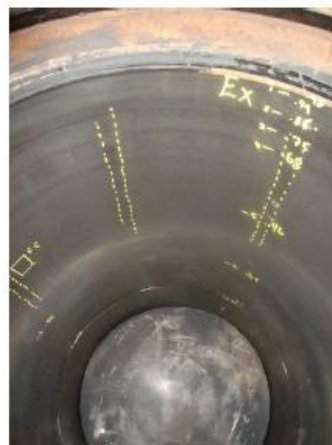
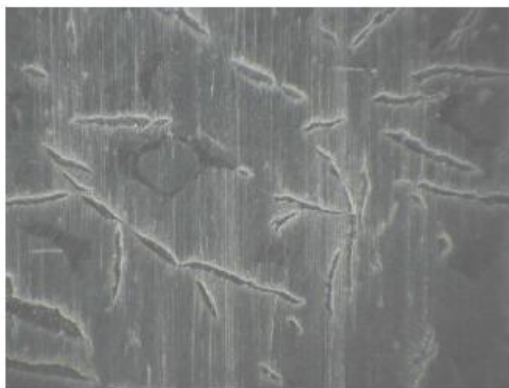
Cylinder unit No 3 was inspected and found in good condition. On this unit a test with soft delivery cylinder lubrication is active.

The liner surface was found to be smooth, with no indication of abnormal wear. The surface lamella structure appeared slightly corrosive with an open graphite lamella structure, as indicated on the photo below, taken in measuring point No. 2, manoeuvring side.

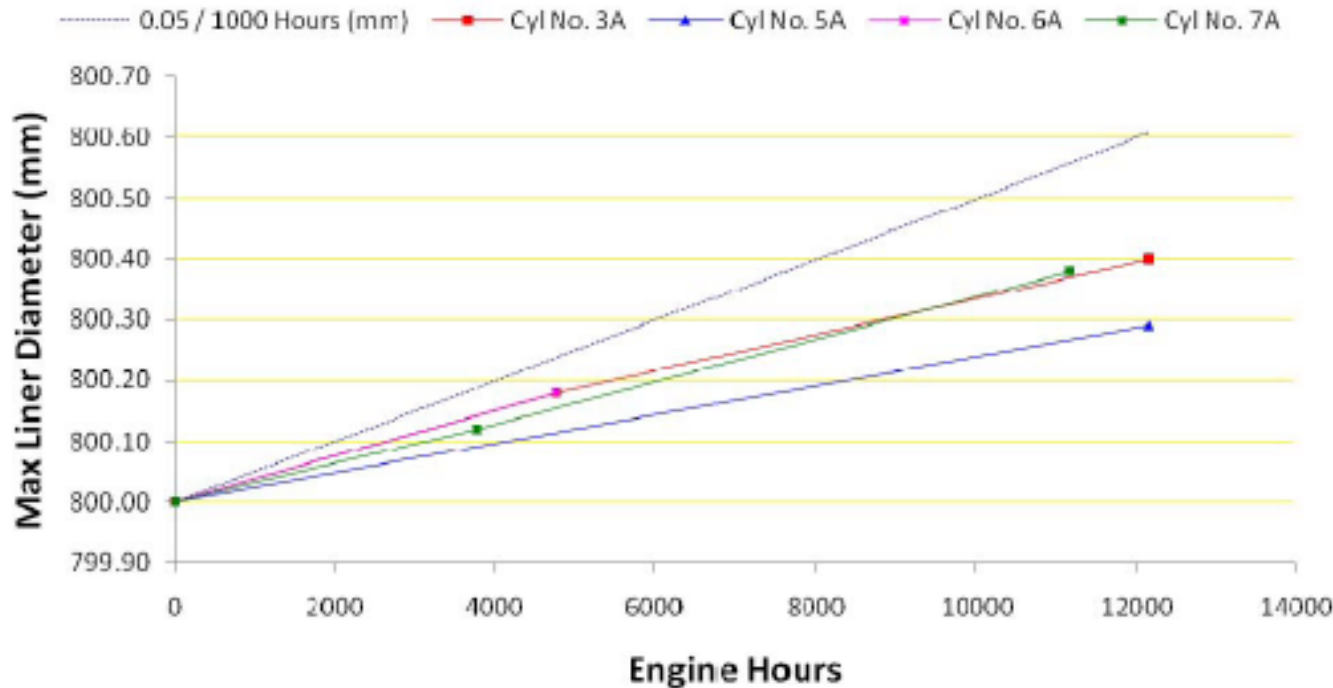
## Max. Liner Diameter Analysis MAERSK BOGOR HYUNDA-AA3093

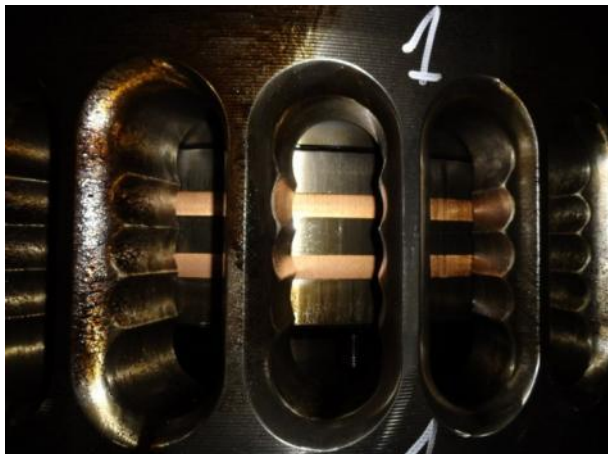
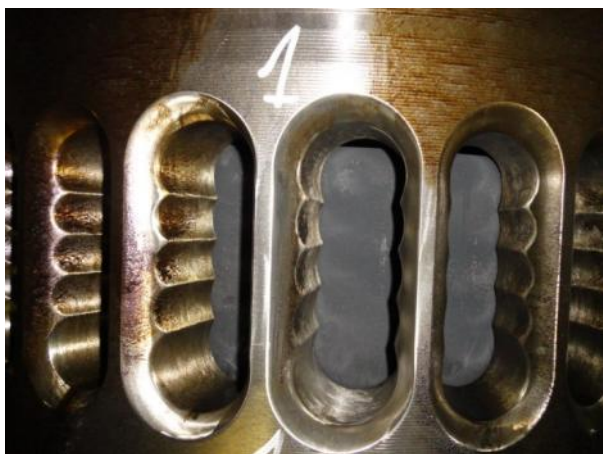
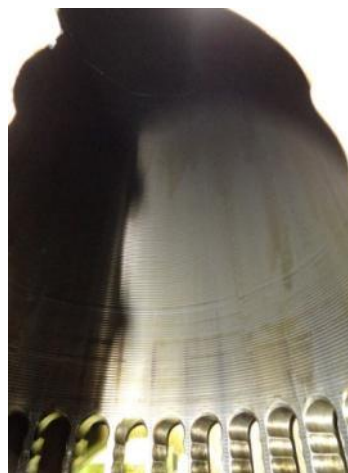
**Cylinder no. 1 at 1,803 hours: Excellent Condition**
